## Spring 1982

## House Condition Spring 1982

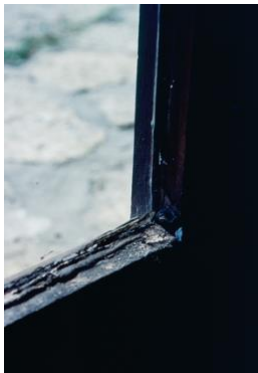
Two winters and all the moisture running down the windows over its life had produced dry rot in many places and there were these large single pane sections slipping into the wood frame leading to air leakage in gaps at the top of some. The house did have moisture issues. It was not uncommon to have a ¼ inch of frost form on the south window wall nightly. This was particularly true when the inside pool was a fish and water plant pool.

33 years of deep frost developing nightly and washing down the single pane of glass had cause dry rot and after two years empty the glass had slipped into the wood in some places creating air gaps at the tops of the panes.

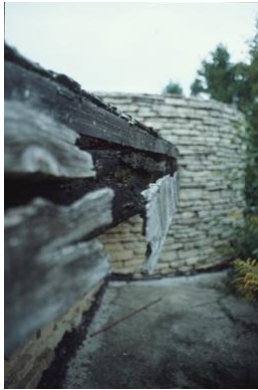
They say a picture says 1000 words. The roof though, technically flat, had a very slight tilt to the rear. There was never anything done to protect the roof's fascia from all the runoffs. The water came off the roof to travel over and behind the fascia. Of note in this photo is the concrete roof to the shop which has a block wall to the north and the back of the rear kitchen wall to the south. A door from the tunnel connects to this space which is open to the utility portion of the tower.
